TOWN OF WALLINGFORD-STORMWATER MASTER PLAN

WALLINGFORD, VERMONT

FINAL REPORT February 22, 2019

Prepared by: Watershed Consulting Associates, LLC 430 Shelburne Road P.O. Box 4413 Burlington, VT 05406 P: 802.497.2367 info@watershedca.com

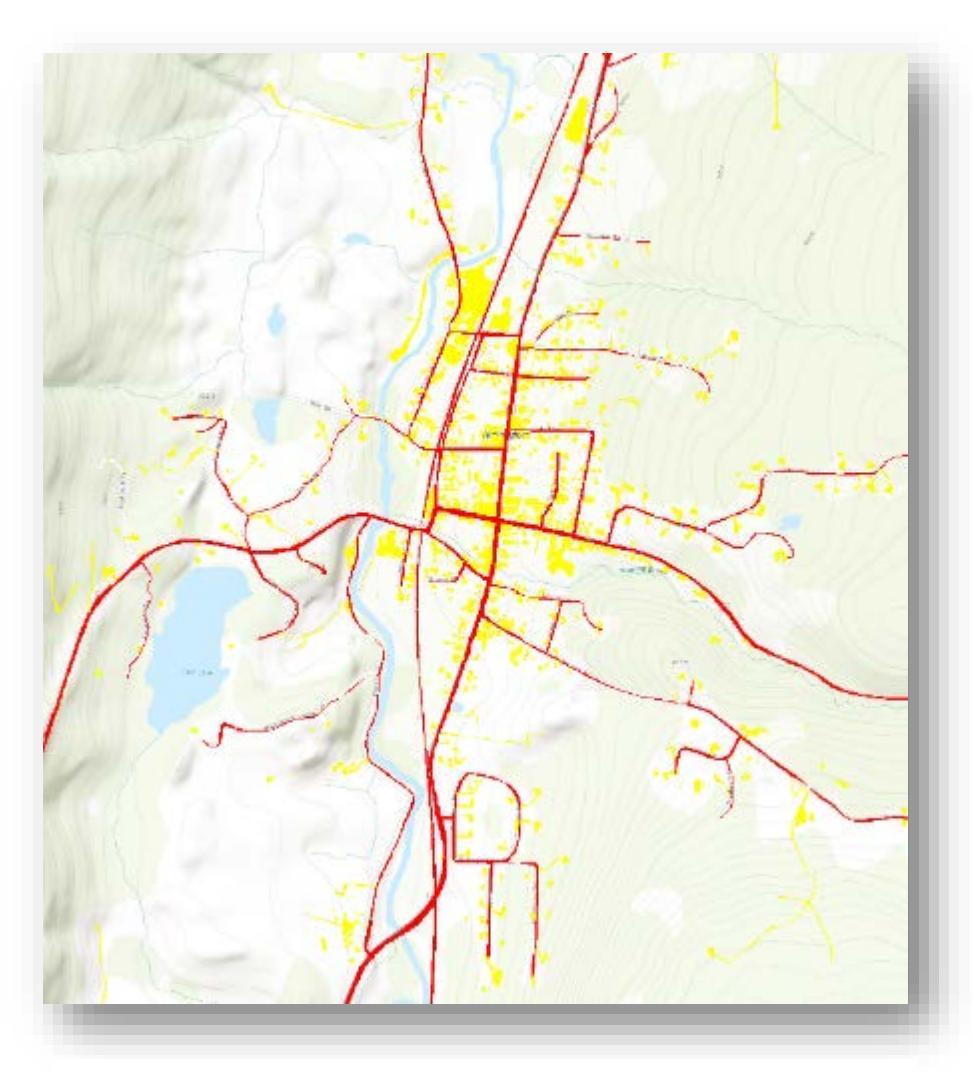
Figure 1: Downtown Wallingford showing road-related impervious cover in red and all other impervious cover in yellow. Approximately half the impervious cover in Wallingford is road-related.

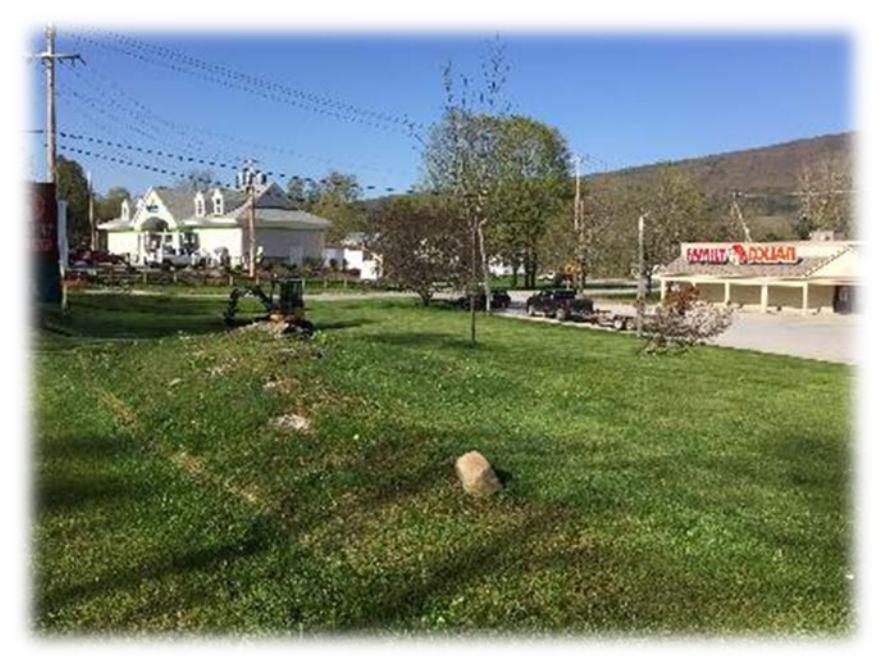
Figure 2: The potential site where sub-surface chambers could be installed as a filtration practice is show in this photo. Only the green space in front of the parking area would be developed for stormwater management.

A system of sub-surface chambers will be installed in the front yard of the Wallingford Family Dollar. The property is owned by James Mulkin, who has expressed his support of the project to the concept design phase. The Family Dollar Corporation has also expressed their support, as long as the chamber system does not interfere with their daily operations. The chambers will have to be installed so as to avoid the ledge outcrop on the site. The

concept calls for laying the chambers out in such a way as to stagger each of the rows. The system will be sized to treat the full Water Quality volume (WQv) from the majority of Wallingford's developed downtown area. During geotechnical assessment, groundwater was found at a depth of approximately 6.0-6.5'. The chambers will be located above that elevation and will be underdrained using an 8" perforated underdrain pipe, located below a 2' layer of sand that will act as a filter for pollutants. No runoff will be infiltrated. Runoff events larger than the WQv storm will bypass the system via an overflow and be routed to the same ditch they currently flow to. No change will be made to runoff routing for storms larger than the WQv storm.

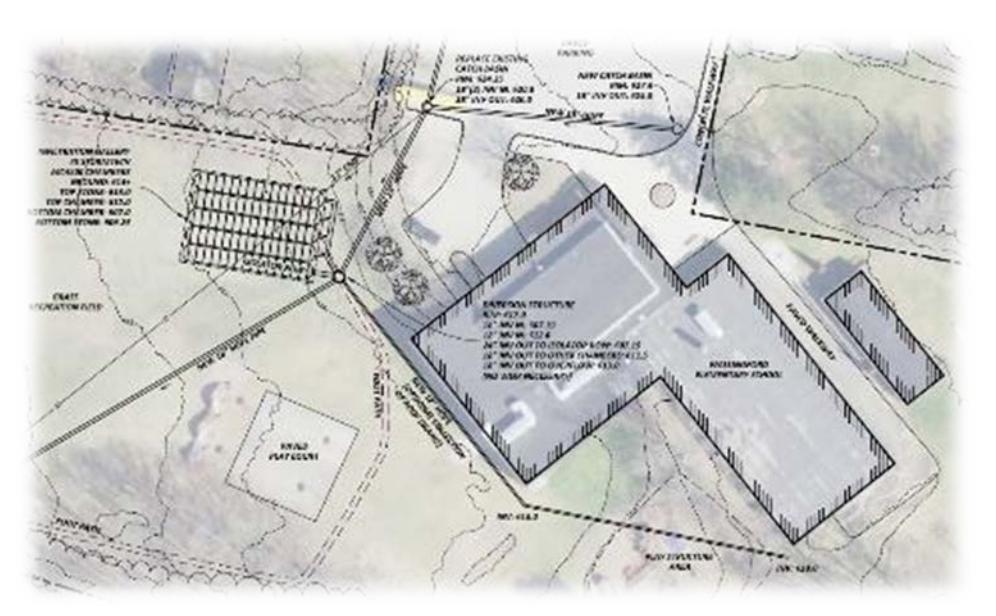
Figure 3: Vignette from the 30% concept design for the Wallingford School infiltration chamber system. The system would take drainage from the entire school area, including some of the road and residential neighborhood adjacent to the school.

Figure 4: Vignette from the 30% concept design for the Wallingford School infiltration chamber system. The system would take drainage from the entire school area, including some of the road and residential neighborhood adjacent to the school.

The system will consist of a series of 5x15 Storm Tech MC-4500 subsurface infiltration chambers designed to fully infiltrate the Water Quality volume (WQv) from 22.75 а acre drainage area, 20.04% of which (or 4.55 acres) is impervious. This drainage area includes the school's main parking lot and rooftop (provided

the roof drain pipes can be tied to the system – plans are inconclusive on this matter). Larger storms will bypass the system via an overflow pipe to the Roaring Brook. Geotechnical assessment at the site found a favorable infiltration rate of approximately 1.3" per hour. Conversations with the Town Road Foreman, who has extensive knowledge of this particular site, indicates that there may be some buried debris on the site below the ball field (old concrete tanks or other debris from the high school demolition). This may complicate excavation for the chambers to some degree.

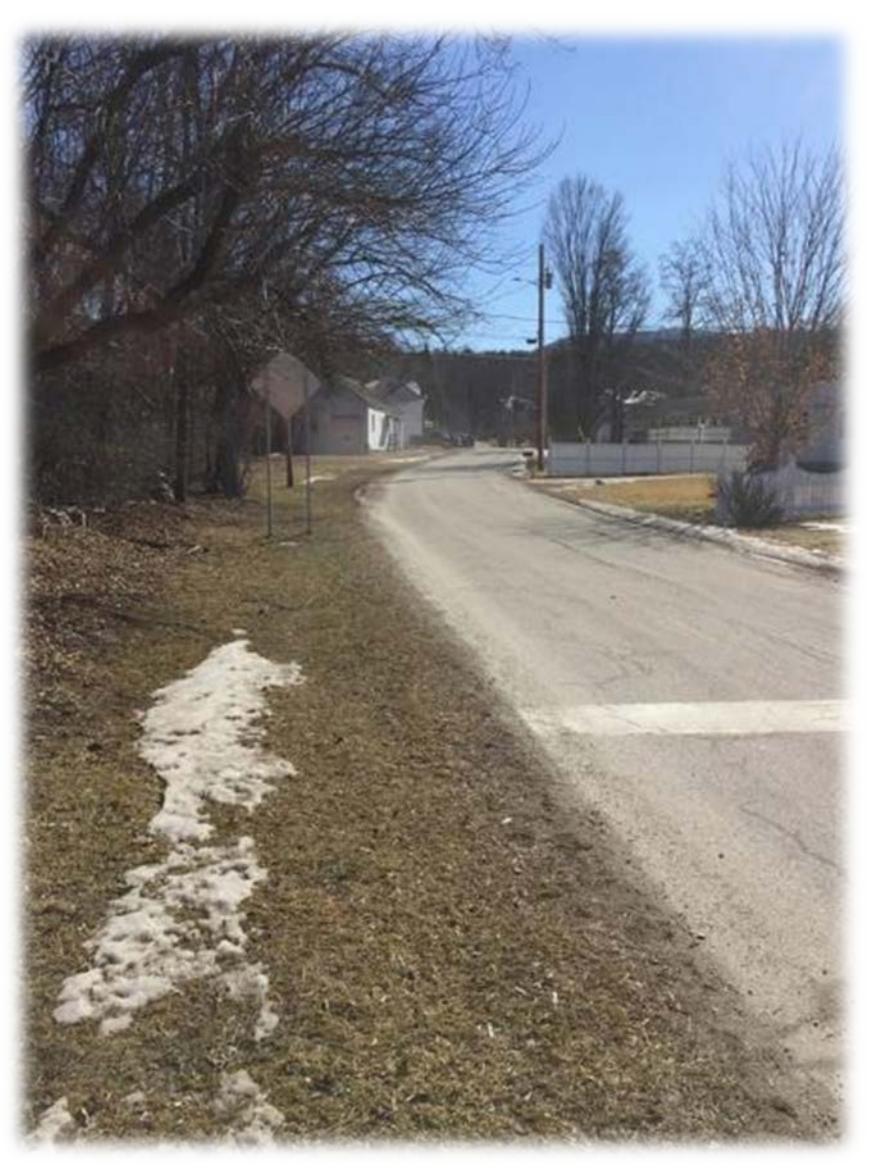
Figure 5: Florence Avenue right-of-way greenspace where the infiltration swale would be installed. The swale would essentially formalize and improve the existing ROW.

Figure 6: Florence Avenue right-of-way greenspace where the infiltration swale would be installed. The swale would essentially formalize and improve the existing ROW.

Between the road edge and the berm separating the road right-of-way from Roaring Brook, an infiltration swale could be dug to allow for runoff from Florence Avenue several and surrounding residences to drain and infiltrate into soil. The rightof-way is publicly owned. The improvement would consist of excavating the ROW to specifications, amending 18-24" of soil with bioretention media, and replanting with grass seed. The swale would be sloped such that the bottom would allow for up to 1.75' of ponding prior to overflow. An overflow pipe would be installed through the existing berm to allow for runoff bypass to the Brook. This would allow the berm to continue to provide some measure of local flood control, though it should be noted that the primary reason that localized flooding occurs in this location is the undersized

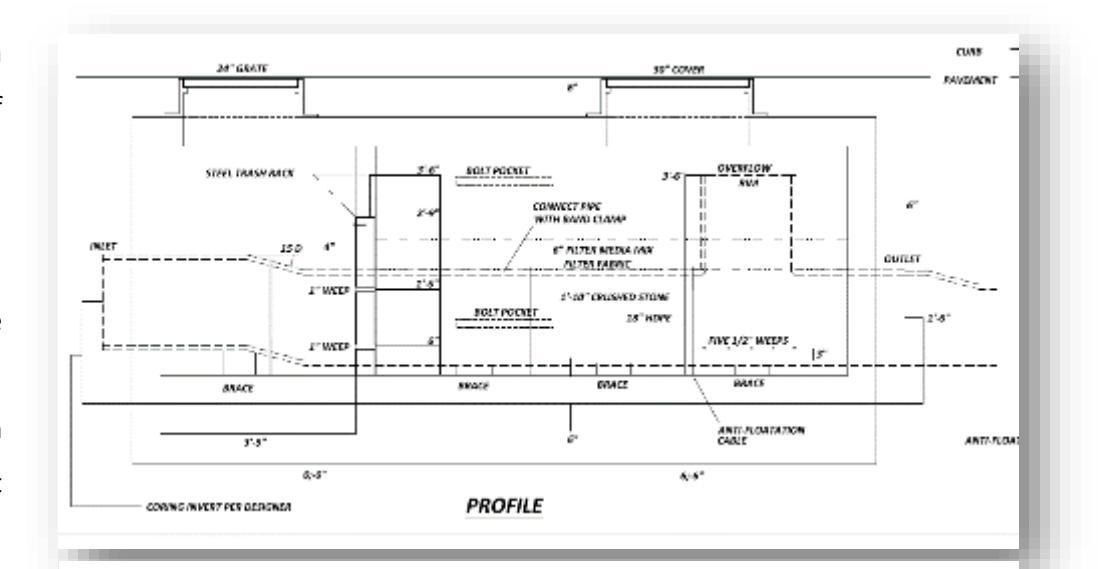
Figure 7: Vignette of the modified media box filter originally developed by the University of New Hampshire Stormwater Center and modified for installation in an 'online' configuration by Watershed Consulting Associates, LLC and Lakeside Environmental Group.

Figure 8: Vignette of the modified media box filter originally developed by the University of New Hampshire Stormwater Center and modified for installation in an 'online' configuration by Watershed Consulting Associates, LLC and Lakeside Environmental Group.

overflow pipe. Each three-piece unit (as originally designed) is designed to treat up to 0.5 acres of impervious cover. An additional segment can be added for each additional 0.25 acres of impervious cover. This practice was chosen as it non-proprietary, is easily serviced, has easily replaceable filter media, and can be installed in the road right of way without impacting traffic, plowing, parking, or adding infiltrated runoff to the road subbase, which was a particular concern expressed by VTrans for this location. VTrans has been appraised of this design and is generally favorable of the concept, though they noted that they aren't necessarily in favor of the increased operation and maintenance that will come with these practices.

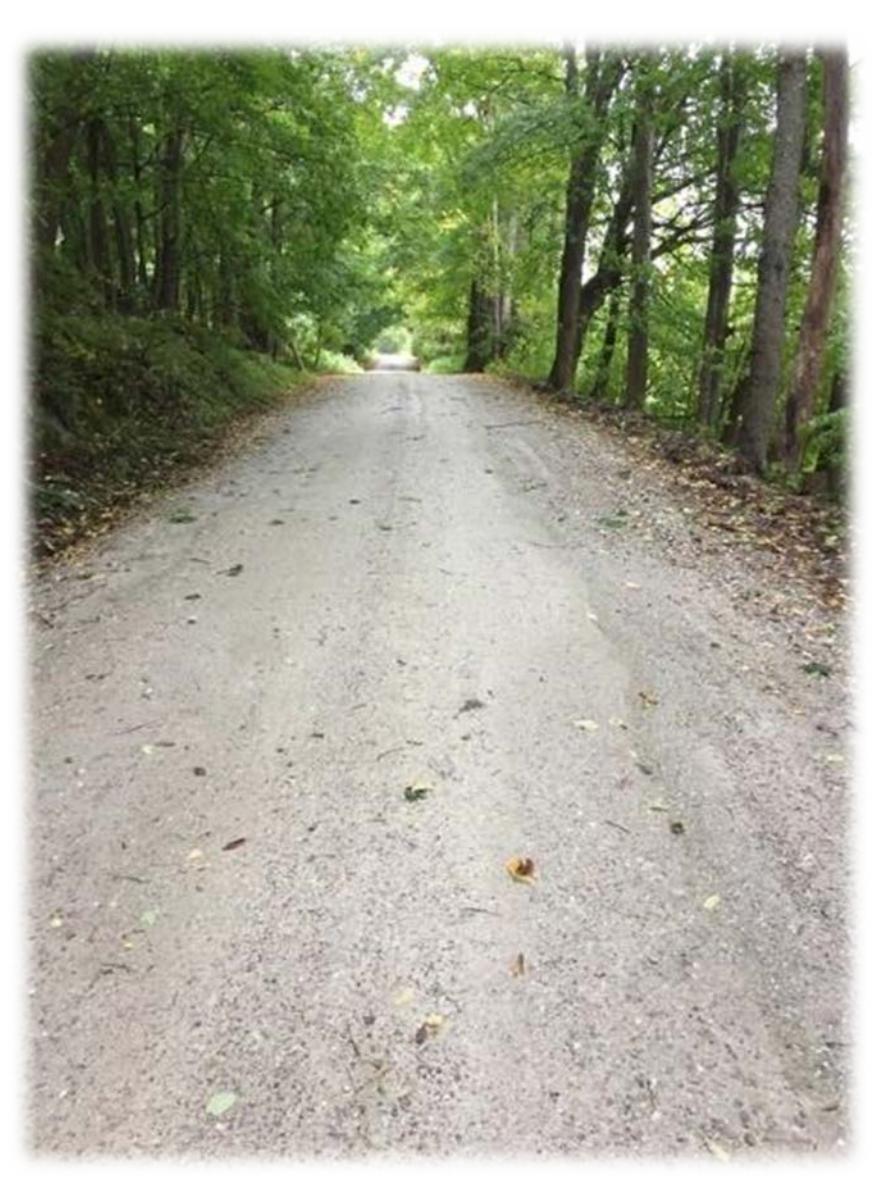
Figure 9: West Hill Road 4. This road segment needs to be re-crowned.

This segment near 1799 West Hill Road is 1,115' long and has long sections of eroded ditches flowing to a small tributary. Nearly 50% of this overall segment needs to be re-crowned (though it is important to note that the assessment occurred in the fall of the year), and around 50% of the ditching needs to be stabilized in some fashion. In addition, there are undersized culverts along this road segment. In order to bring the segment into compliance with MRGP requirements there are a number of best management practices (BMPs) that should be installed. See the Attachment 6.2 – Road Erosion Solutions for a description of the specific

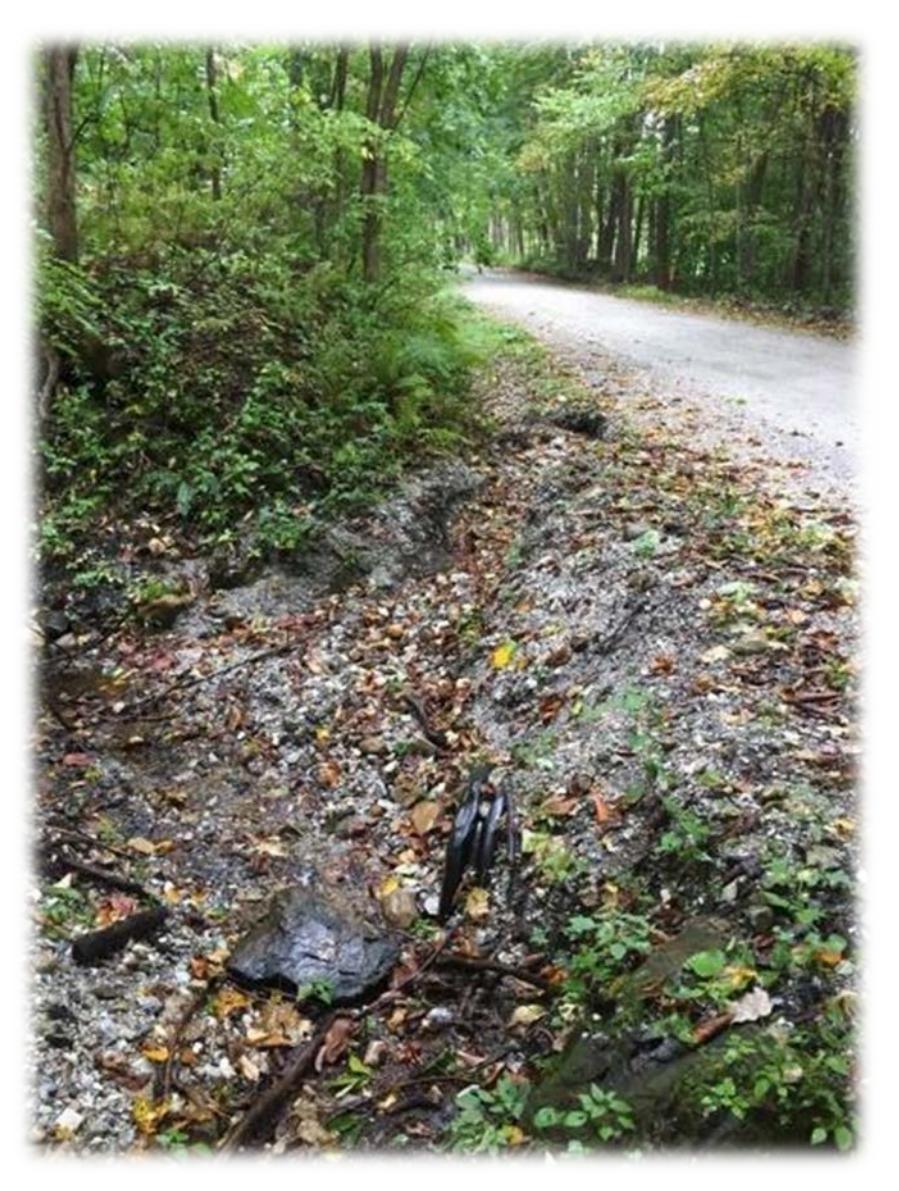
Figure 10: West Hill Road 5. The turnout at the bottom of the road is eroding directly into the tributary.

This segment, which is just downhill of 2048 West Hill Road, is approximately 415' long and has an eroded, steep ditch on the uphill side of the road that flows directly to a small tributary. The ditch needs re-shaping and armoring with stone. Additionally, a section of grader berm needs to be removed and a new road crossing culvert could be installed to take water from the uphill ditch into an open field area on the opposite side of the road before the ditch meets the tributary. Some re-crowning of the road is necessary. See the Attachment 6.2 - Road Erosion Solutions for a description of the specific practices and materials estimate.

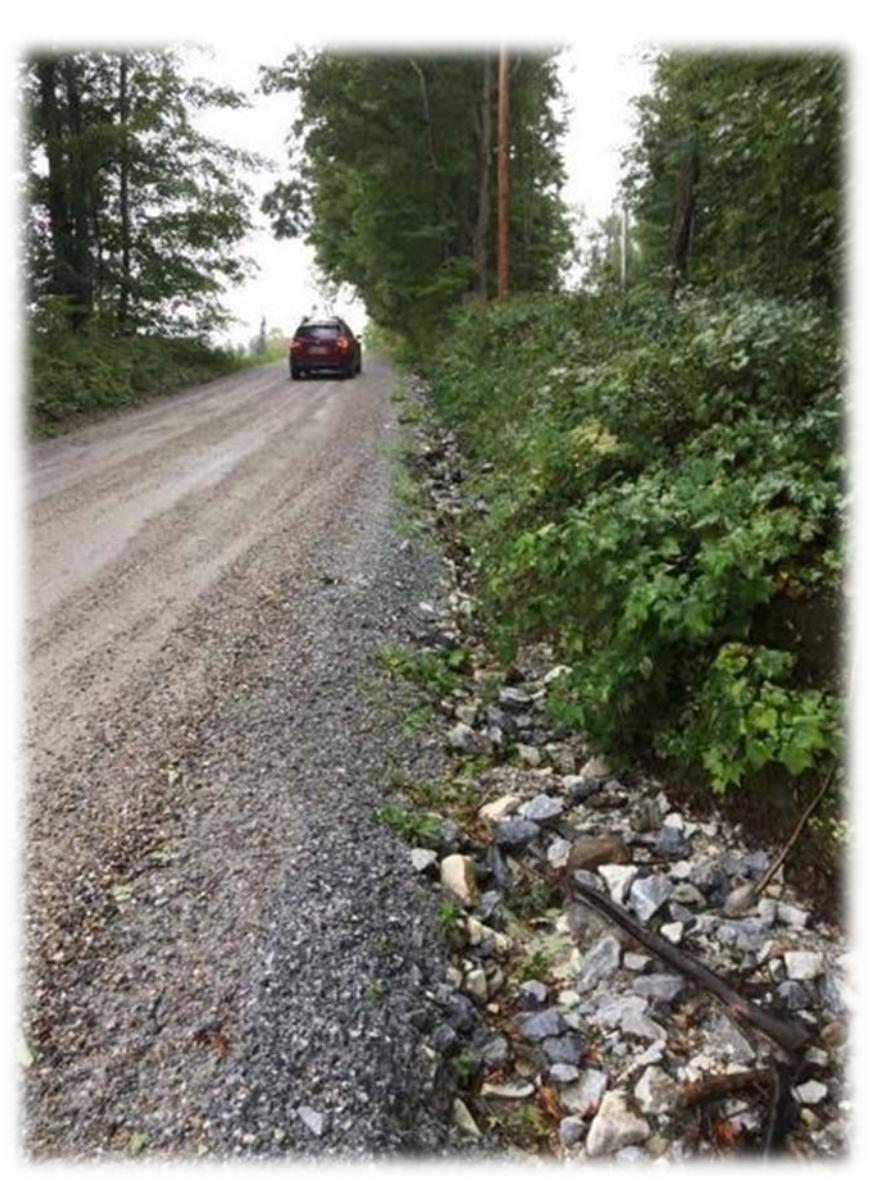
Figure 11: West Hill Road 3. Grader berm needs removing and the ditch is eroding.

This segment of road, downhill from 1348 West Hill Road, is approximately 545' long with a 450' long section of ditch on the uphill side of the road that is eroded and needs to be re-shaped and armored. One existing culvert may need to be replaced, or at least dug out of the sediment that is blocking the inlet and outlet, and there is an opportunity to install three road crossing culverts to rock aprons to divert runoff and sediment away from the tributary at the bottom of the hill. There is a 320' section of the road that has a grader berm that should be removed. The road segment also needs to be re-crowned. See the Attachment 6.2 – Road Erosion Solutions for a description of the specific practices and materials estimate.

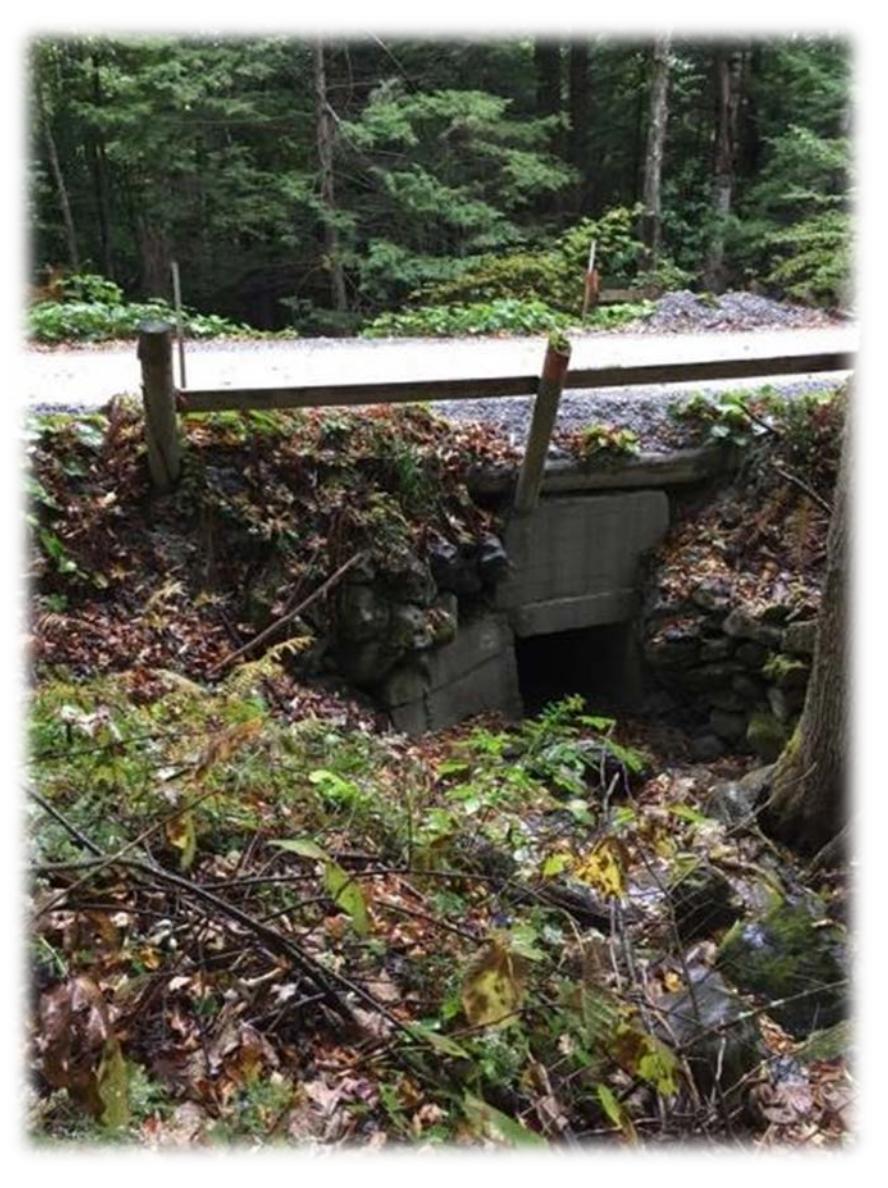
Figure 12: West Hill Road 1. Misaligned and undersized culvert at bottom of road segment.

This road segment, located downhill of 518 West Hill road, is approximately 580' long and has ditches on both sides of the road that are steep and eroded that lead directly to a small tributary. The road segment should be recrowned, though there was no evidence of a grader berm. There are two opportunities to install a road crossing culvert to a rock apron, though driveways on the receiving side of the road will be a complicating factor. Additionally, the stream crossing culvert at the bottom of the road segment appears to be undersized and in poor condition. At minimum a culvert that matches the stream's bankfull width should be installed. А hydraulic or bankfull width

assessment of the culvert was not done as part of this scope of work. See the Attachment 6.2 – Road Erosion Solutions for a description of the specific practices and materials estimate.
